INSPECTION REPORT
586 Mountain Fancy Drive
Big Lake NC 28715

INSPECTION DATE
📅 12/15/2020
🕒 1:00 PM

Single Family (2 story)

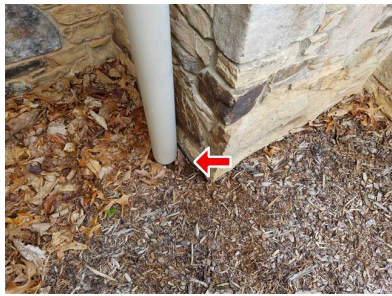
1.3 Item 1 (Picture)

Drain line has sunken or pulled loose from downspout. This area needs repair.

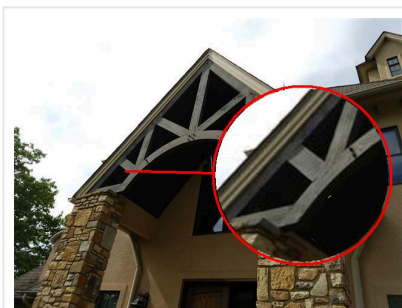
2.0 Item 1 (Picture)

(2) The gable wood work on at least two locations shows signs of some damage from carpenter bees etc. and need repair and prep and paint.

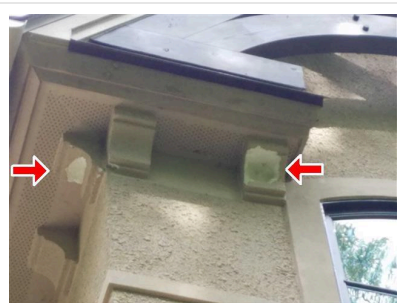
2.0 Item 2 (Picture)

(3) Some repair areas noticed

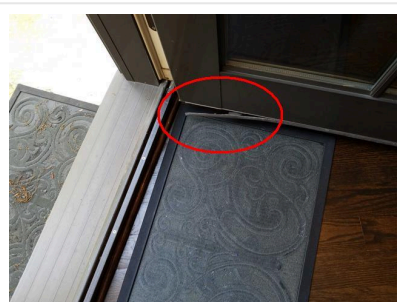
2.1 Item 1 (Picture)
balcony from kitchen

(1) Weather stripping on a few exterior doors are loose, missing or damaged in areas..

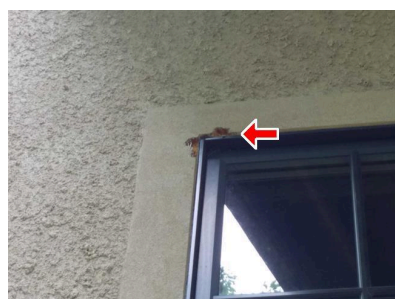
2.2 Item 1 (Picture)

Window trim is damaged at the rear of home over the extra room (seen from ground level).

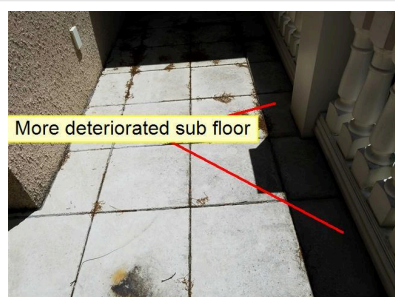
2.3 Item 1 (Picture)

(1) The master suite balcony floor is deteriorated. Water has come in along front or outer band where tile or trim failed to cover seam when installed. Tile is cracked in an area. Guard rail and tile will need to be replaced. Guard rail can be re used but tile likely cannot. Subfloor will need to be replaced along front length of balcony and side nearest door and install tile and seal.

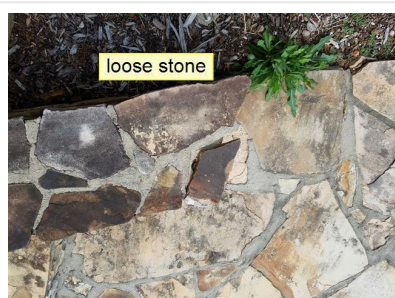
2.3 Item 4 (Picture)

(2) Loose stone at steps of home at entry.

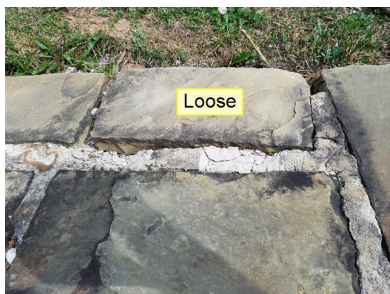
2.4 Item 3 (Picture)

(2) Retaining wall has at least one loose stone and some areas need grout again and sealant applied.

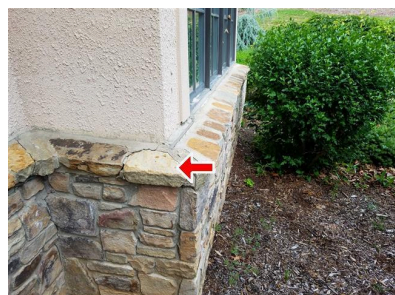
3.1 Item 1 (Picture)

Rock wall has settled or continues to settle and repair signs indicate it has settled previously and has settled more or again. Repairs are needed to wall and cement chinking. See roof section at Gutters and downspouts for more repair recommendations.

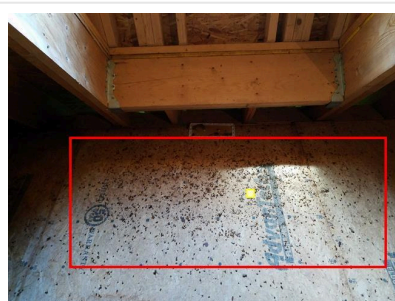
3.5 Item 1 (Picture)

Insects dead from entering around window area in attic (FYI).

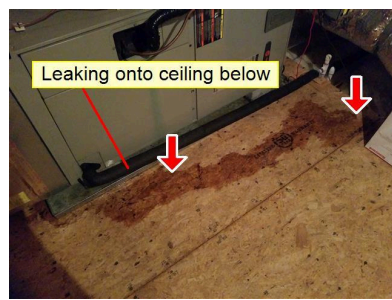
4.0 Item 1 (Picture)

Air handler was leaking condensation into the drain pan. The drain pan was full and eventually the safety switch did cut off unit. However it still leaked which could mean that the pan itself may leak at a seam? Note: The listing agent called a HVAC person who did replace the filter that was clogged and troubleshooted the

system. I did not see if he removed the standing water. Not doing so can cause more to leak onto the ceiling below. The ceiling below was dripping water and has already stained. I did not inspect for mold and it could develop. Repairs if air handler was repaired will likely be prime seal ceiling and re paint.

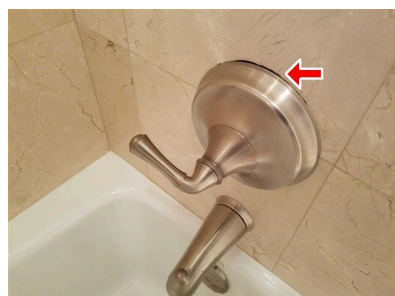
5.1 Item 3 (Picture)

(3) Protective cover for fixture has sagged or loosened to where water can get in behind wall at light blue guest bedroom upstairs and at master shower,

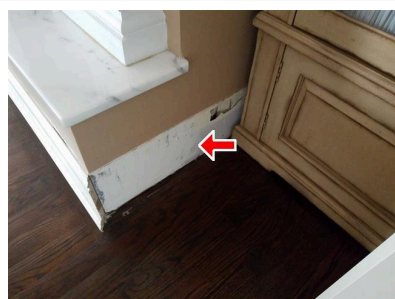
8.1 Item 1 (Picture)

Baseboard and trim missing from both sides of fireplace in Master bedroom.

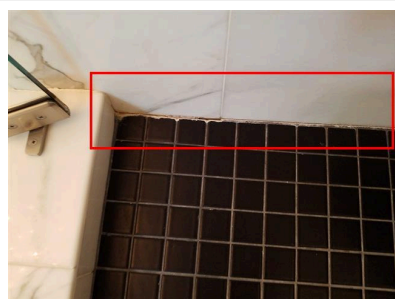
8.2 Item 1 (Picture)

Tile floor in Master needs grout where missing and reseal.

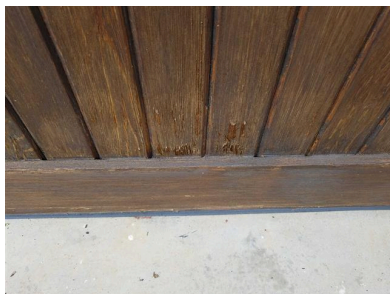
9.3 Item 1 (Picture)

All three garage doors are no longer protected by the stain or sealant and are starting to peel, fade and eventually deteriorate.

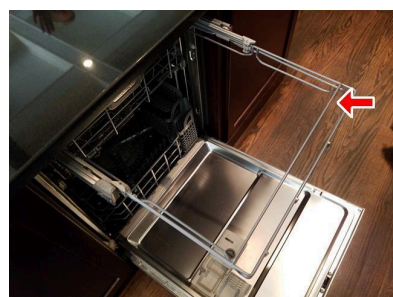
10.0 Item 1 (Picture)

It appears that the silverware tray is missing?
